Manhole Inspection Summary

Manhole # S69Y__013MH

Insp Date: **5/5/08 11:35 AM**

Location Address: **6400 Beckley St.**

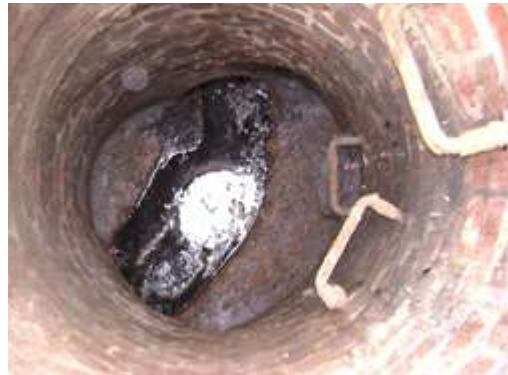
Top View

Condition: ☐ Sound ☐ Cracked ☐ Root Intrusion ☐ Deteriorated ☐ Leaks ☒ **Debris**

Steps Count: **3** Missing: **0** ☒ **Corroded**
